Colorado Department of Education

School Report

Seventh Street ES

Sep 24, 2019

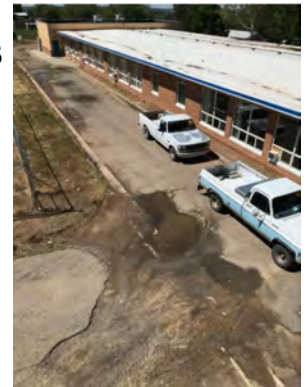
Parking lot and roadway flexible pavement (bituminous) includes a 12" thick gravel base course for large paved areas. This system is damaged/failing and should be budgeted for repair and/or replacement.

Auto generated renewal for Parking Lot and Roadway Flexible Pavement - Base Course. System Description: Parking lot and roadway flexible pavement (bituminous) includes a 12" thick gravel base course for large paved areas. This system is damaged/failing and should be budgeted for repair and/or replacement.

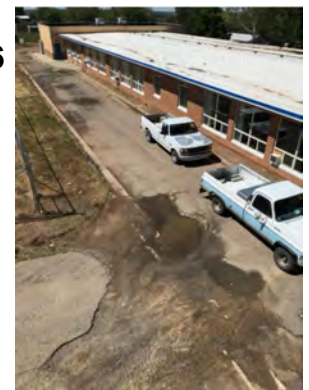
Parking Lot and Roadway Flexible Pavement - Intermediate Course

Parking lot and roadway flexible pavement includes a 3" thick bituminous intermediate binder course for large paved areas. This system is damaged/failing and should be budgeted for repair and/or replacement.

Auto generated renewal for Parking Lot and Roadway Flexible Pavement - Intermediate Course. System Description: Parking lot and roadway flexible pavement includes a 3" thick bituminous intermediate binder course for large paved areas. This system is damaged/failing and should be budgeted for repair and/or replacement.

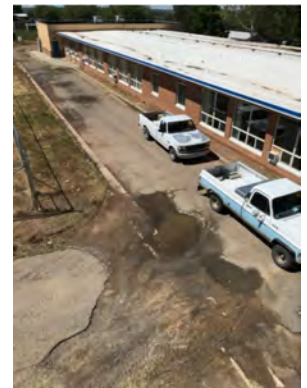
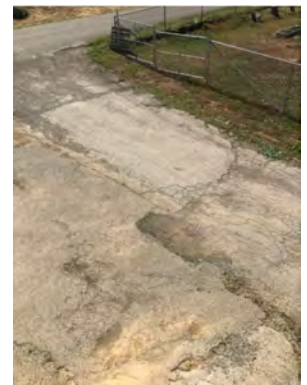
Parking lot and roadway flexible pavement includes a 2" thick bituminous wearing surface course for large paved areas. This system is damaged/failing and should be budgeted for repair and/or replacement.

Auto generated renewal for Parking Lot and Roadway Flexible Pavement - Surface Course. System Description: Parking lot and roadway flexible pavement includes a 2" thick bituminous wearing surface course for large paved areas. This system is damaged/failing and should be budgeted for repair and/or replacement.

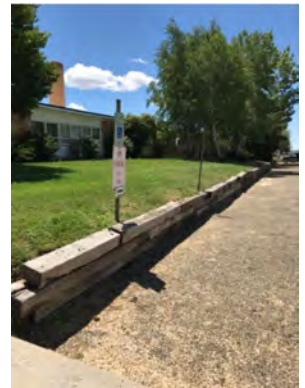
Site development includes retaining wall 2-ft. high consisting of pressure-treated 8"x8" wood ties. Years remaining have been increased because the system is currently functioning, however the system is beyond its useful life and should be budgeted for repair/replacement.

Auto generated renewal for Site Development - Retaining Wall - Wood Ties. System Description: Site development includes retaining wall 2-ft. high consisting of pressure-treated 8"x8" wood ties. Years remaining have been increased because the system is currently functioning, however the system is beyond its useful life and should be budgeted for repair/replacement.

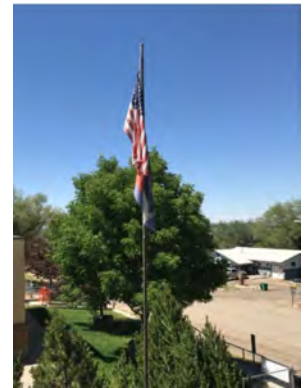
Landscaping includes trees with prepared beds. Years remaining have been increased because the system is currently functioning, however the system is beyond its useful life and should be budgeted for repair/replacement.

Auto generated renewal for Landscaping - Trees. System Description: Landscaping includes trees with prepared beds. Years remaining have been increased because the system is currently functioning, however the system is beyond its useful life and should be budgeted for repair/replacement.

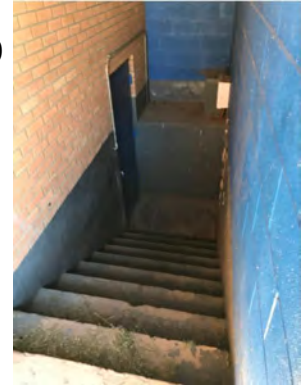
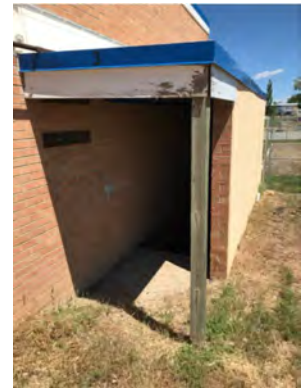
Exterior concrete stairs entering facility. Years remaining have been increased because the system is currently functioning, however the system is beyond its useful life and should be budgeted for repair/replacement.

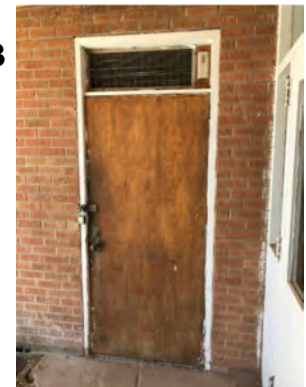
Exterior doors include 3 x 7 wood door and frame with hinges, lockset, exit hardware and closer. Includes painted door and painted frame. Years remaining have been increased because the system is currently functioning, however the system is beyond its useful life and should be budgeted for repair/replacement.

Auto generated renewal for Door Assembly - 3 x 7 Wood. System Description: Exterior doors include 3 x 7 wood door and frame with hinges, lockset, exit hardware and closer. Includes painted door and painted frame. Years remaining have been increased because the system is currently functioning, however the system is beyond its useful life and should be budgeted for repair/replacement.

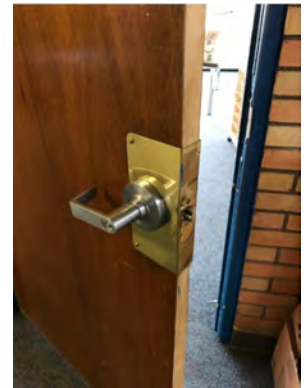
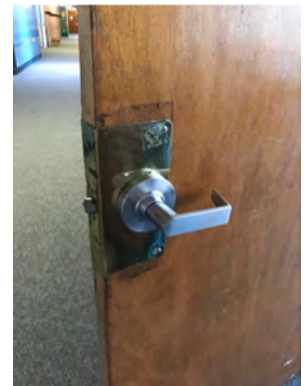
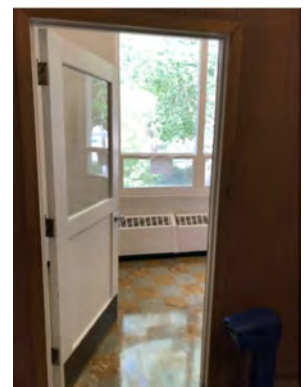
Interior doors include non-rated 3 x 7 Wd (wood) door and frame with hinges, lockset and closer. Includes finished door and frame. Years remaining have been increased because the system is currently functioning, however the system is beyond its useful life and should be budgeted for repair/replacement.

Auto generated renewal for Swinging Doors - 3 x 7 Wd - 1952. System Description: Interior doors include non-rated 3 x 7 Wd (wood) door and frame with hinges, lockset and closer. Includes finished door and frame. Years remaining have been increased because the system is currently functioning, however the system is beyond its useful life and should be budgeted for repair/replacement.

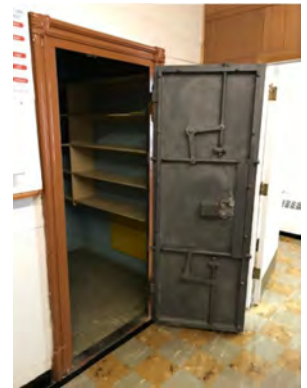
Special interior doors consist of vault door and frame. Years remaining have been increased because the system is currently functioning, however the system is beyond its useful life and should be budgeted for repair/replacement.

Swinging Doors - Security Vault Renewal

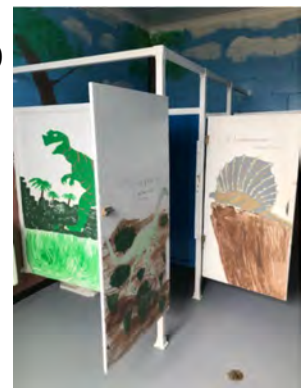
Restrooms are equipped with wall-hung partitions. Years remaining have been increased because the system is currently functioning, however the system is beyond its useful life and should be budgeted for repair/replacement.

Auto generated renewal for Toilet Partitions. System Description: Restrooms are equipped with wall-hung partitions. Years remaining have been increased because the system is currently functioning, however the system is beyond its useful life and should be budgeted for repair/replacement.

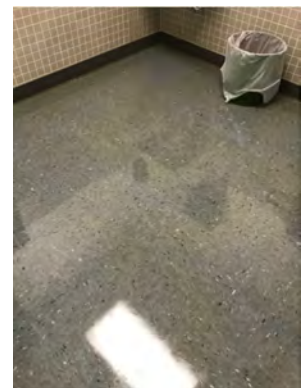
Floor finishes include areas of VCT (Vinyl Composition Tile) flooring and base. Contains asbestos under tiles. Years remaining have been increased because the system is currently functioning, however the system is beyond its useful life and should be budgeted for repair/replacement.

Auto generated renewal for VCT - 2002. System Description: Floor finishes include areas of VCT (Vinyl Composition Tile) flooring and base. Contains asbestos under tiles. Years remaining have been increased because the system is currently functioning, however the system is beyond its useful life and should be budgeted for repair/replacement.

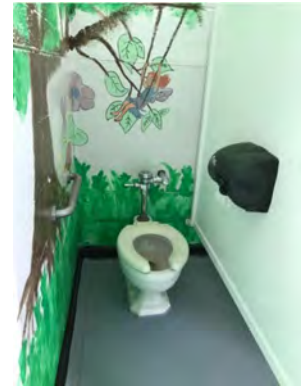
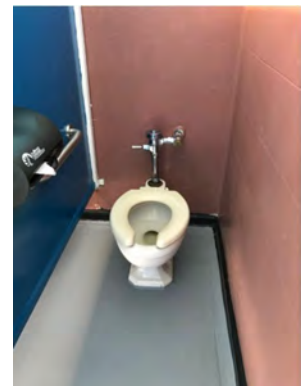
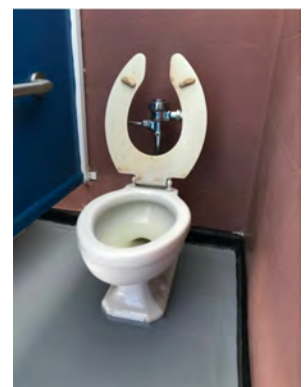
The restroom fixtures include urinals, water closets and lavatories. Years remaining have been increased because the system is currently functioning, however the system is beyond its useful life and should be budgeted for repair/replacement.

Auto generated renewal for Restroom Fixtures 1952. System Description: The restroom fixtures include urinals, water closets and lavatories. Years remaining have been increased because the system is currently functioning, however the system is beyond its useful life and should be budgeted for repair/replacement.

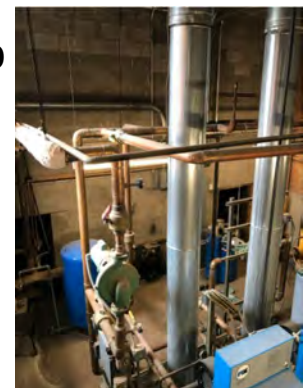
HVAC distribution is provided by a two-pipe distribution system. Years remaining have been increased because the system is currently functioning, however the system is beyond its useful life and should be budgeted for repair/replacement.

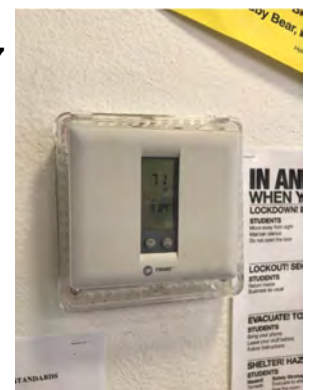
The building has electric wall-mounted thermostats, control valves, and a basic local HVAC control system. Years remaining have been increased because the system is currently functioning, however the system is approaching the end of its useful life and should be budgeted for repair/replacement.

Auto generated renewal for Electric Controls. System Description: The building has electric wall-mounted thermostats, control valves, and a basic local HVAC control system. Years remaining have been increased because the system is currently functioning, however the system is approaching the end of its useful life and should be budgeted for repair/replacement.

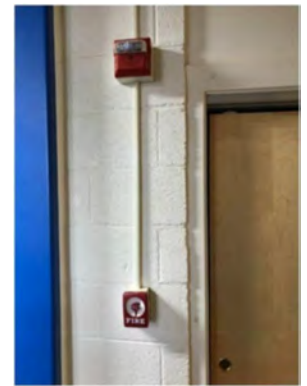
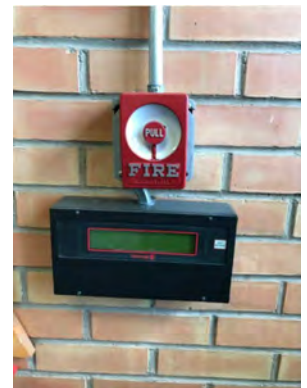
The fire alarm system includes head end equipment, pull stations, audio/visual strobes, visual strobes, smokes, conduit, wire and connections. Years remaining have been increased because the system is currently functioning, however the system is beyond its useful life and should be budgeted for repair/replacement.

Auto generated renewal for Fire Alarm System. System Description: The fire alarm system includes head end equipment, pull stations, audio/visual strobes, visual strobes, smokes, conduit, wire and connections. Years remaining have been increased because the system is currently functioning, however the system is beyond its useful life and should be budgeted for repair/replacement.

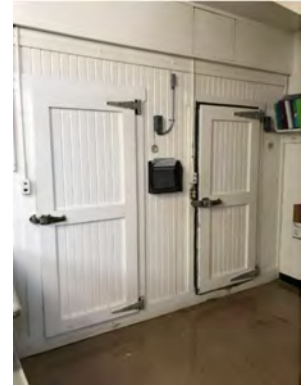
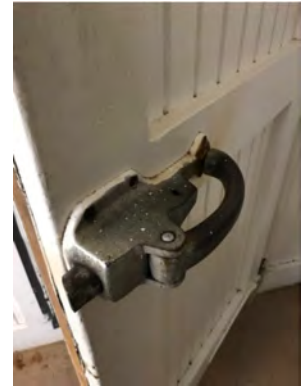
Equipment and furnishings includes kitchen equipment. Years remaining have been increased because the system is currently functioning, however the system is beyond its useful life and should be budgeted for repair/replacement.

Auto generated renewal for Kitchen Equipment. System Description: Equipment and furnishings includes kitchen equipment. Years remaining have been increased because the system is currently functioning, however the system is beyond its useful life and should be budgeted for repair/replacement.

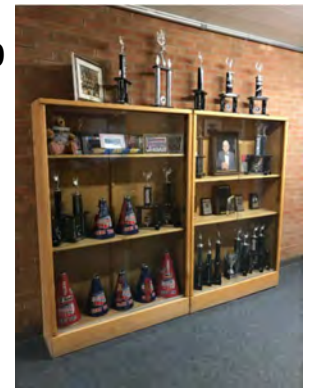
The building includes laminate casework, including wall and under-counter cabinets and counter-tops. Years remaining have been increased because the system is currently functioning, however the system is beyond its useful life and should be budgeted for repair/replacement.
