Colorado Department of Education

School Report

Seventh Street ES

Sep 24, 2019

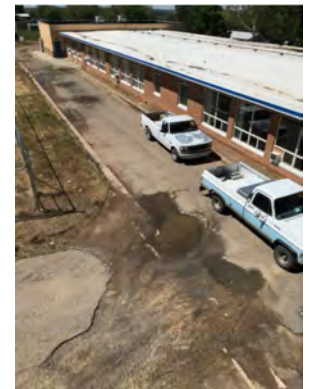
Parking lot and roadway flexible pavement (bituminous) includes a 12" thick gravel base course for large paved areas. This system is damaged/failing and should be budgeted for repair and/or replacement.

Auto generated renewal for Parking Lot and Roadway Flexible Pavement - Base Course. System Description: Parking lot and roadway flexible pavement (bituminous) includes a 12" thick gravel base course for large paved areas. This system is damaged/failing and should be budgeted for repair and/or replacement.

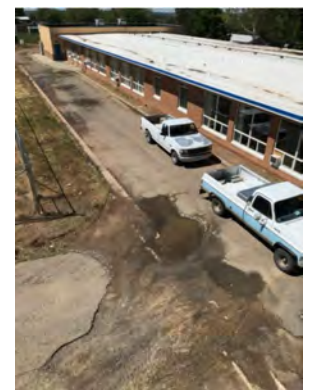
Parking Lot and Roadway Flexible Pavement - Intermediate Course

Parking lot and roadway flexible pavement includes a 3" thick bituminous intermediate binder course for large paved areas. This system is damaged/failing and should be budgeted for repair and/or replacement.

Auto generated renewal for Parking Lot and Roadway Flexible Pavement - Intermediate Course. System Description: Parking lot and roadway flexible pavement includes a 3" thick bituminous intermediate binder course for large paved areas. This system is damaged/failing and should be budgeted for repair and/or replacement.

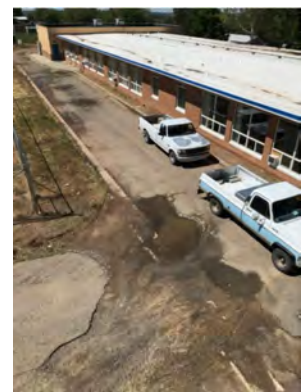
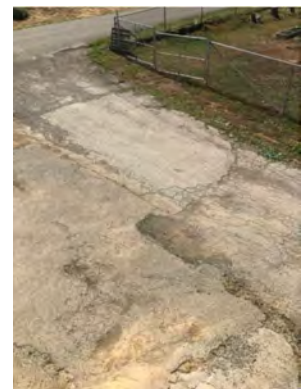
Parking lot and roadway flexible pavement includes a 2" thick bituminous wearing surface course for large paved areas. This system is damaged/failing and should be budgeted for repair and/or replacement.

Auto generated renewal for Parking Lot and Roadway Flexible Pavement - Surface Course. System Description: Parking lot and roadway flexible pavement includes a 2" thick bituminous wearing surface course for large paved areas. This system is damaged/failing and should be budgeted for repair and/or replacement.

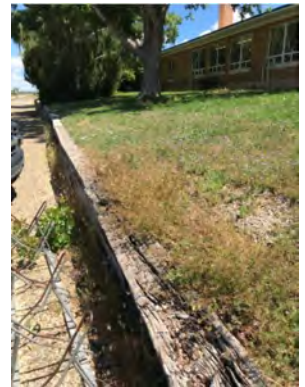
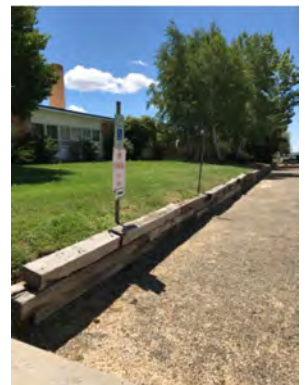
Site development includes retaining wall 2-ft. high consisting of pressure-treated 8"x8" wood ties. Years remaining have been increased because the system is currently functioning, however the system is beyond its useful life and should be budgeted for repair/replacement.

Auto generated renewal for Site Development - Retaining Wall - Wood Ties. System Description: Site development includes retaining wall 2-ft. high consisting of pressure-treated 8"x8" wood ties. Years remaining have been increased because the system is currently functioning, however the system is beyond its useful life and should be budgeted for repair/replacement.

| | | Action: | Site Development - Retaining Wall - Wood Ties Renewal |

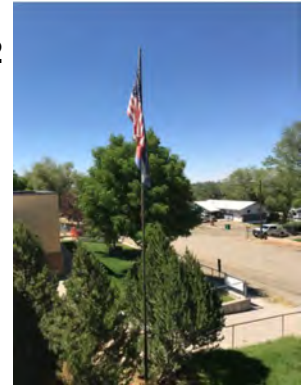
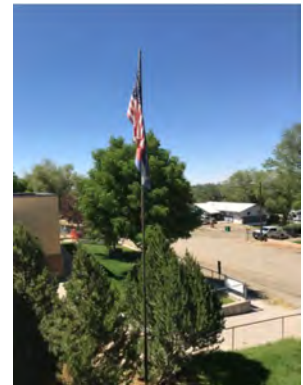
Site development includes aluminum flagpoles. Years remaining have been increased because the system is currently functioning, however the system is beyond its useful life and should be budgeted for repair/replacement.

Auto generated renewal for Site Development - Flagpoles - Aluminum. System Description: Site development includes aluminum flagpoles. Years remaining have been increased because the system is currently functioning, however the system is beyond its useful life and should be budgeted for repair/replacement.

Cost: \$8,640 **Priority:** 3 - Due within 5 Years of Inspection
Action Date: 7/30/24 **Prime Sys:** Flagpoles
Action: Site Development - Flagpoles - Aluminum Renewal

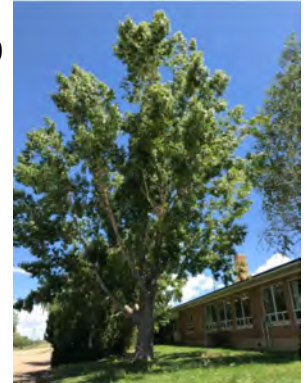
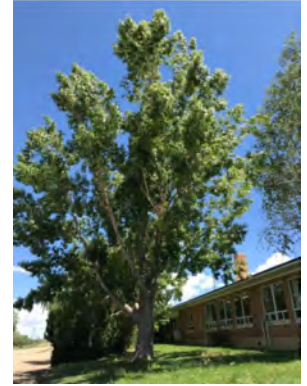
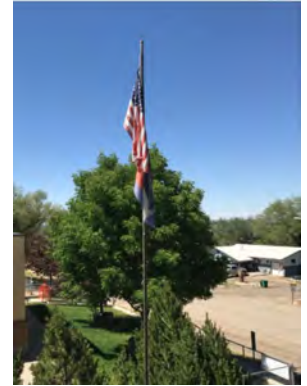
Landscaping includes trees with prepared beds. Years remaining have been increased because the system is currently functioning, however the system is beyond its useful life and should be budgeted for repair/replacement.

Auto generated renewal for Landscaping - Trees. System Description: Landscaping includes trees with prepared beds. Years remaining have been increased because the system is currently functioning, however the system is beyond its useful life and should be budgeted for repair/replacement.

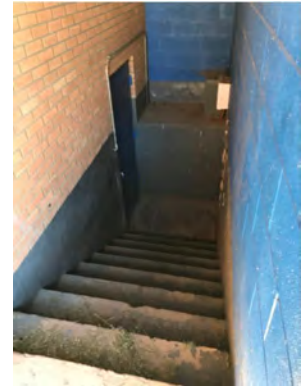
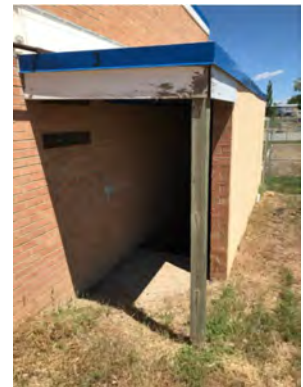
Auto generated renewal for Exterior Stairs - Concrete. System Description: Exterior concrete stairs entering facility. Years remaining have been increased because the system is currently functioning, however the system is beyond its useful life and should be budgeted for repair/replacement.

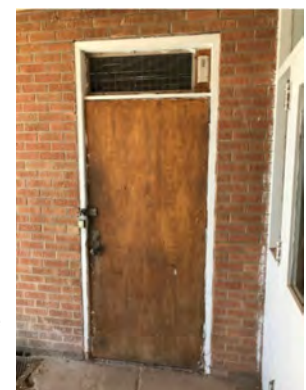
Auto generated renewal for Door Assembly - 3 x 7 Wood. System Description: Exterior doors include 3 x 7 wood door and frame with hinges, lockset, exit hardware and closer. Includes painted door and painted frame. Years remaining have been increased because the system is currently functioning, however the system is beyond its useful life and should be budgeted for repair/replacement.

| | | Action: | Door Assembly - 3 x 7 Wood Renewal |

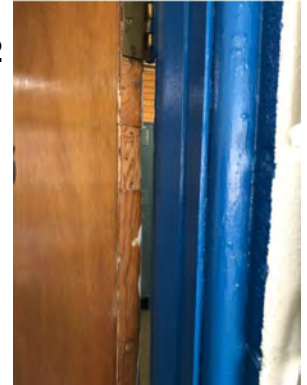
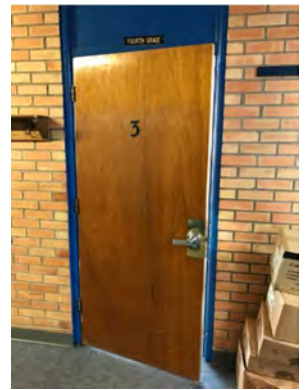
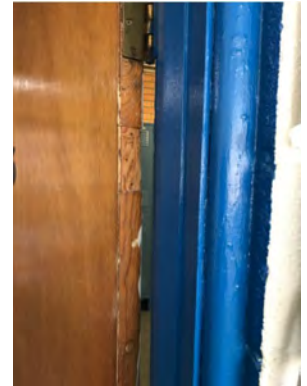
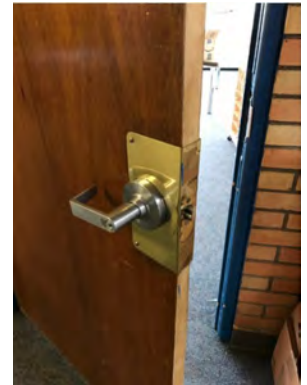
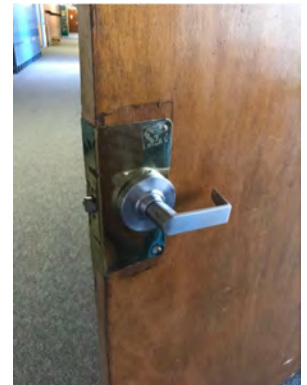
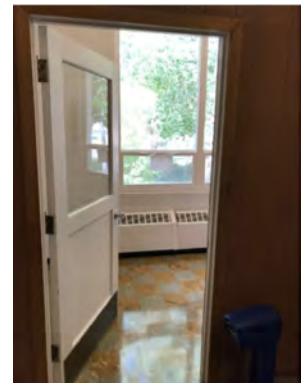
Interior doors include non-rated 3 x 7 Wd (wood) door and frame with hinges, lockset and closer. Includes finished door and frame. Years remaining have been increased because the system is currently functioning, however the system is beyond its useful life and should be budgeted for repair/replacement.

Auto generated renewal for Swinging Doors - 3 x 7 Wd - 1952. System Description: Interior doors include non-rated 3 x 7 Wd (wood) door and frame with hinges, lockset and closer. Includes finished door and frame. Years remaining have been increased because the system is currently functioning, however the system is beyond its useful life and should be budgeted for repair/replacement.

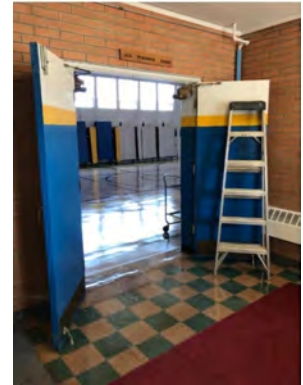
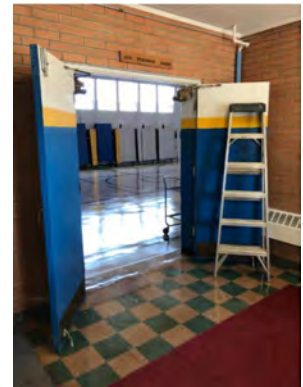
| | | Action: | Swinging Doors - Pair - 6 x 7 Wd - 1952 Renewal |

Interior doors include a pair of non-rated 3 x 7 Wd (wood) doors and frame with hinges, locksets and closers. Includes finished doors and frame. Years remaining have been increased because the system is currently functioning, however the system is beyond its useful life and should be budgeted for repair/replacement.

Auto generated renewal for Swinging Doors - Pair - 6 x 7 Wd - 1952. System Description: Interior doors include a pair of non-rated 3 x 7 Wd (wood) doors and frame with hinges, locksets and closers. Includes finished doors and frame. Years remaining have been increased because the system is currently functioning, however the system is beyond its useful life and should be budgeted for repair/replacement.

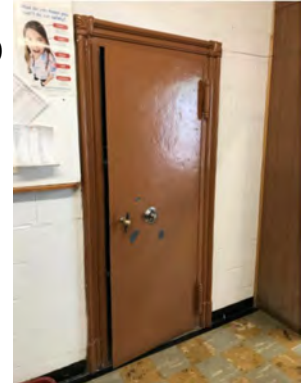
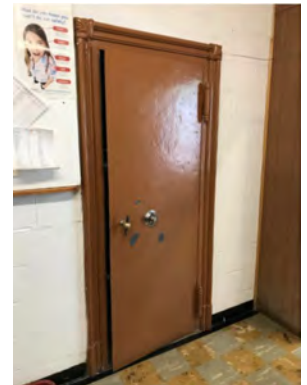
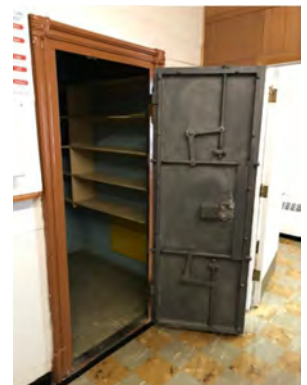
Swinging Doors - Security Vault Renewal

Special interior doors consist of vault door and frame. Years remaining have been increased because the system is currently functioning, however the system is beyond its useful life and should be budgeted for repair/replacement.

Auto generated renewal for Swinging Doors - Security Vault. System Description: Special interior doors consist of vault door and frame. Years remaining have been increased because the system is currently functioning, however the system is beyond its useful life and should be budgeted for repair/replacement.

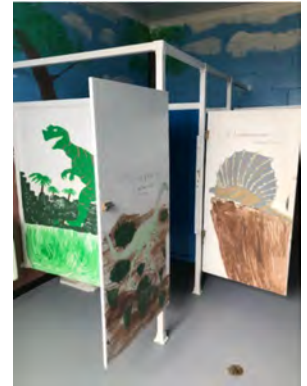
Restrooms are equipped with wall-hung partitions. Years remaining have been increased because the system is currently functioning, however the system is beyond its useful life and should be budgeted for repair/replacement.

Auto generated renewal for Toilet Partitions. System Description: Restrooms are equipped with wall-hung partitions. Years remaining have been increased because the system is currently functioning, however the system is beyond its useful life and should be budgeted for repair/replacement.

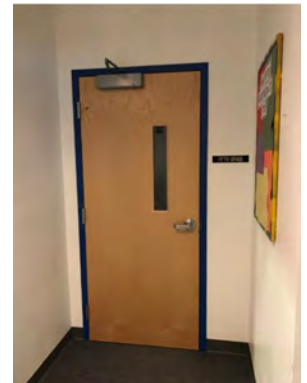
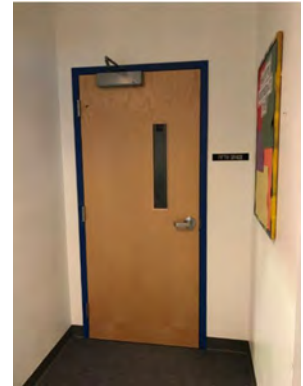
Fittings - Signage - 2002

Finishes include room, door and graphic symbol signs. Years remaining have been increased because the system is currently functioning, however the system is beyond its useful life and should be budgeted for repair/replacement.

Auto generated renewal for Fittings - Signage - 2002. System Description: Finishes include room, door and graphic symbol signs. Years remaining have been increased because the system is currently functioning, however the system is beyond its useful life and should be budgeted for repair/replacement.

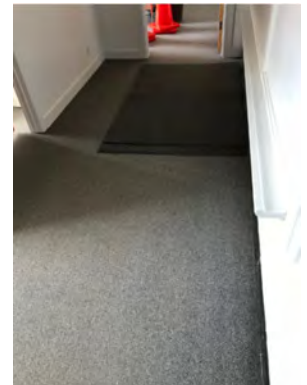
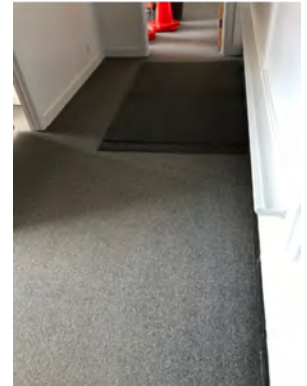
Carpeting - Broadloom - 1995 Renewal

Floor finishes include carpeting and base. Years remaining have been increased because the system is currently functioning, however the system is beyond its useful life and should be budgeted for repair/replacement.

Auto generated renewal for Carpeting - Broadloom - 1995. System Description: Floor finishes include carpeting and base. Years remaining have been increased because the system is currently functioning, however the system is beyond its useful life and should be budgeted for repair/replacement.

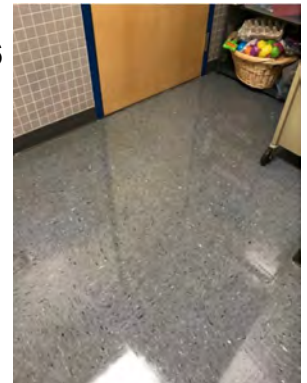
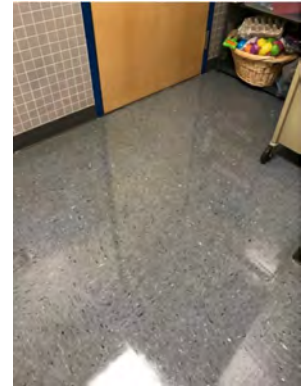
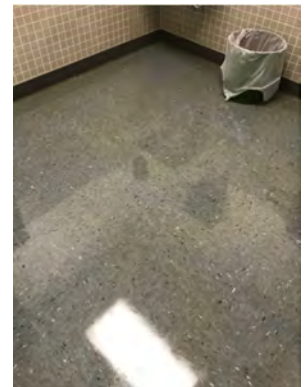
Floor finishes include areas of VCT (Vinyl Composition Tile) flooring and base. Contains asbestos under tiles. Years remaining have been increased because the system is currently functioning, however the system is beyond its useful life and should be budgeted for repair/replacement.

Auto generated renewal for VCT - 2002. System Description: Floor finishes include areas of VCT (Vinyl Composition Tile) flooring and base. Contains asbestos under tiles. Years remaining have been increased because the system is currently functioning, however the system is beyond its useful life and should be budgeted for repair/replacement.

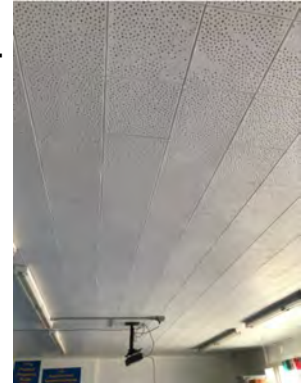
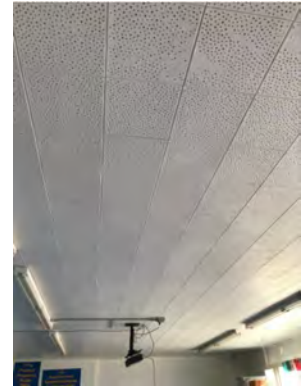
Ceiling finishes included suspended ACT (Acoustic Ceiling Tile) system. Years remaining have been increased because the system is currently functioning, however the system is beyond its useful life and should be budgeted for repair/replacement.

Auto generated renewal for ACT System - 1952. System Description: Ceiling finishes included suspended ACT (Acoustic Ceiling Tile) system. Years remaining have been increased because the system is currently functioning, however the system is beyond its useful life and should be budgeted for repair/replacement.

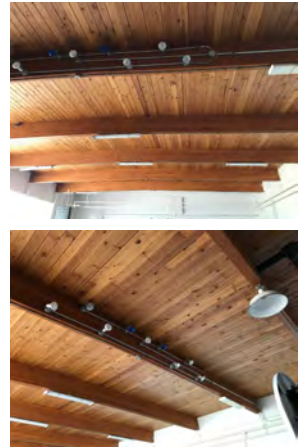
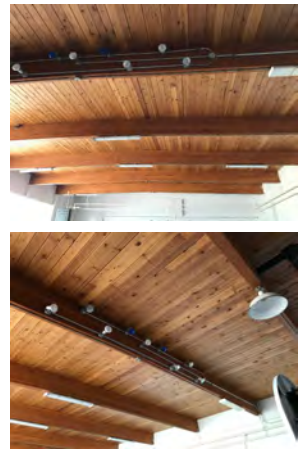
Wood Ceiling - Painted or Stained

Ceiling finishes include finished wood. Years remaining have been increased because the system is currently functioning, however the system is beyond its useful life and should be budgeted for repair/replacement.

Auto generated renewal for Wood Ceiling - Painted or Stained. System Description: Ceiling finishes include finished wood. Years remaining have been increased because the system is currently functioning, however the system is beyond its useful life and should be budgeted for repair/replacement.

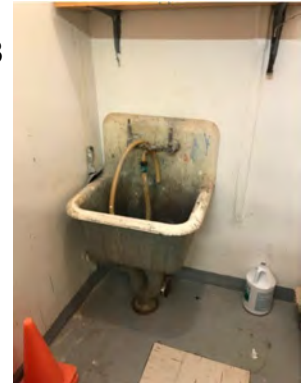
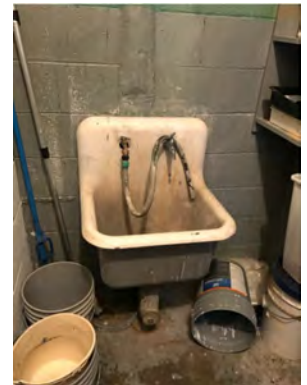
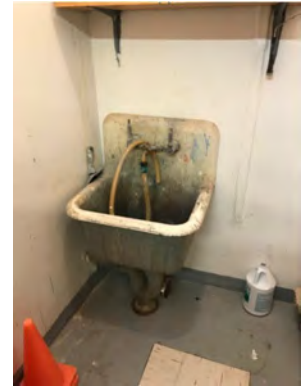
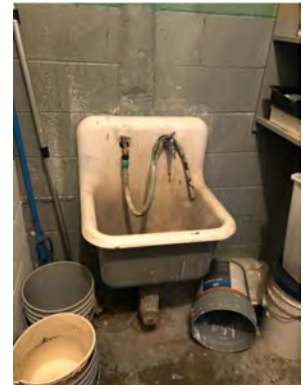
The plumbing fixtures include custodial/utility sinks. Includes rough-in and faucet. Years remaining have been increased because the system is currently functioning, however the system is beyond its useful life and should be budgeted for repair/replacement.

Auto generated renewal for Custodial/Utility Sinks. System Description: The plumbing fixtures include custodial/utility sinks. Includes rough-in and faucet. Years remaining have been increased because the system is currently functioning, however the system is beyond its useful life and should be budgeted for repair/replacement.

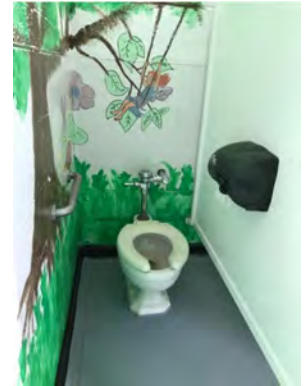
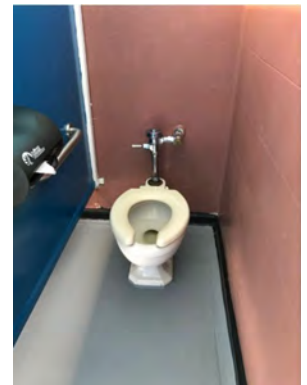
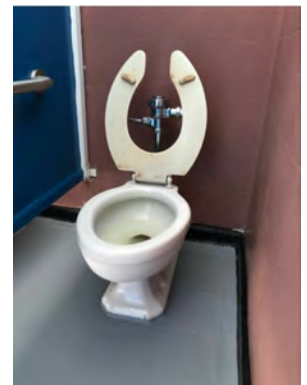
The restroom fixtures include urinals, water closets and lavatories. Years remaining have been increased because the system is currently functioning, however the system is beyond its useful life and should be budgeted for repair/replacement.

Auto generated renewal for Restroom Fixtures 1952. System Description: The restroom fixtures include urinals, water closets and lavatories. Years remaining have been increased because the system is currently functioning, however the system is beyond its useful life and should be budgeted for repair/replacement.

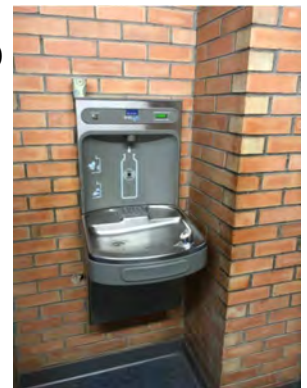
Plumbing fixtures include wall-mounted water coolers with bottle fill.

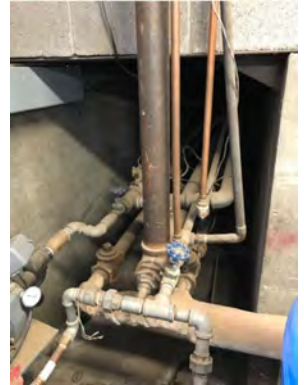
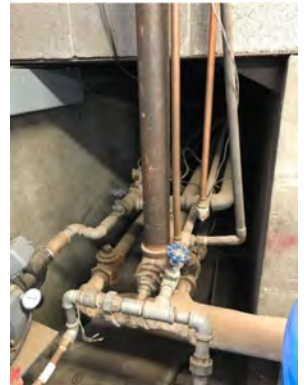
The building domestic water distribution system includes a four inch main line, water meter, backflow preventer, with rough ins included. The water heater is captured in a separate system. Years remaining have been increased because the system is currently functioning, however the system is beyond its useful life and should be budgeted for repair/replacement.

Auto generated renewal for Water Dist Complete - 1952. System Description: The building domestic water distribution system includes a four inch main line, water meter, backflow preventer, with rough ins included. The water heater is captured in a separate system. Years remaining have been increased because the system is currently functioning, however the system is beyond its useful life and should be budgeted for repair/replacement.

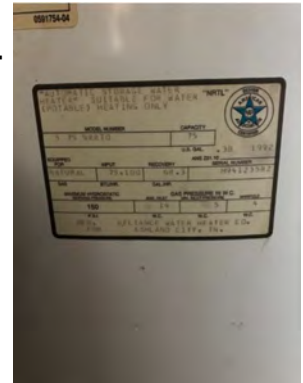
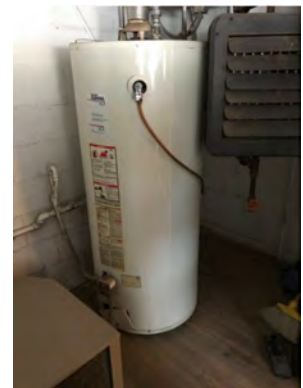
The domestic hot water is provided by an electric water heater. Years remaining have been increased because the system is currently functioning, however the system is beyond its useful life and should be budgeted for repair/replacement.

Auto generated renewal for Water Heater - Electric. System Description: The domestic hot water is provided by an electric water heater. Years remaining have been increased because the system is currently functioning, however the system is beyond its useful life and should be budgeted for repair/replacement.

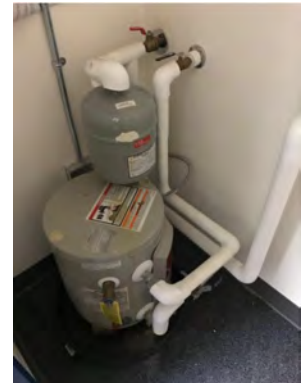
The domestic hot water is provided by a 2.5-gallon point of use electric water heater. Years remaining have been increased because the system is currently functioning, however the system is beyond its useful life and should be budgeted for repair/replacement.

Auto generated renewal for Water Heater - Elec - Point of Use. System Description: The domestic hot water is provided by a 2.5-gallon point of use electric water heater. Years remaining have been increased because the system is currently functioning, however the system is beyond its useful life and should be budgeted for repair/replacement.

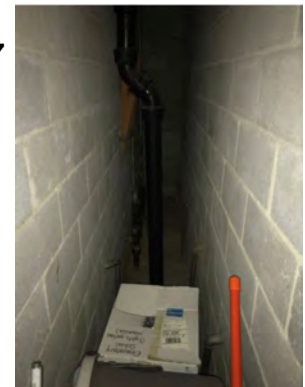
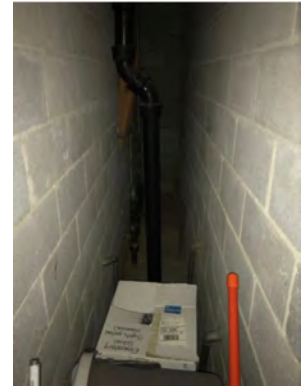
The building includes a sanitary waste system, of cast iron piping, with gravity discharge to the municipal system. Years remaining have been increased because the system is currently functioning, however the system is beyond its useful life and should be budgeted for repair/replacement.

Auto generated renewal for Sanitary Waste - Gravity Discharge - 1952. System Description: The building includes a sanitary waste system, of cast iron piping, with gravity discharge to the municipal system. Years remaining have been increased because the system is currently functioning, however the system is beyond its useful life and should be budgeted for repair/replacement.

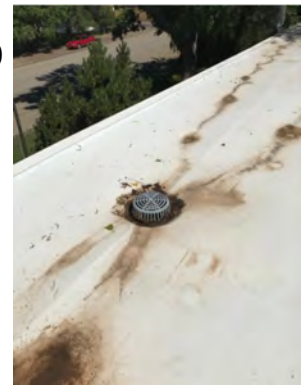
Rain water drainage includes interior piping, roof drains and 4-inch discharge piping by gravity flow. Years remaining have been increased because the system is currently functioning, however the system is beyond its useful life and should be budgeted for repair/replacement.

Auto generated renewal for Roof Drainage - Gravity - 1952. System Description: Rain water drainage includes interior piping, roof drains and 4-inch discharge piping by gravity flow. Years remaining have been increased because the system is currently functioning, however the system is beyond its useful life and should be budgeted for repair/replacement.

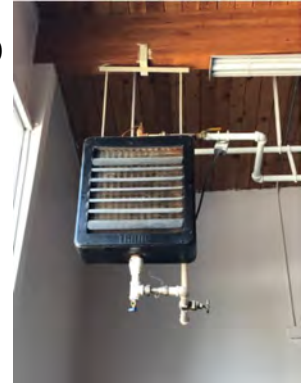
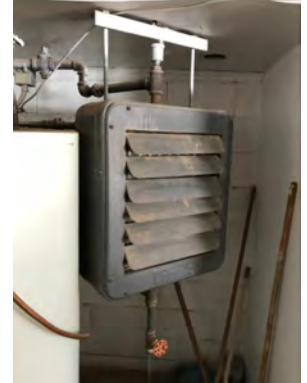
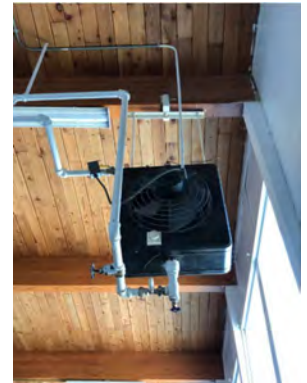
Heating is provided by suspended, forced hot water unit heaters. Years remaining have been increased because the system is currently functioning, however the system is beyond its useful life and should be budgeted for repair/replacement.

Auto generated renewal for Unit Heaters - Hot Water. System Description: Heating is provided by suspended, forced hot water unit heaters. Years remaining have been increased because the system is currently functioning, however the system is beyond its useful life and should be budgeted for repair/replacement.

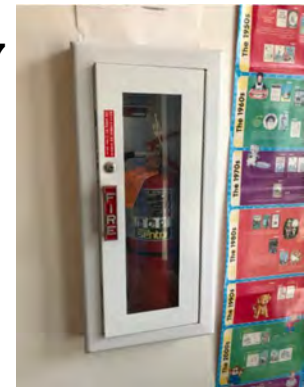
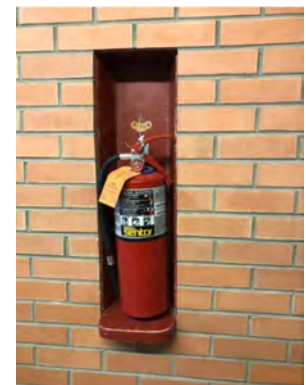
Handheld type dry chemical fire extinguishers are located throughout the building. Includes cabinets.

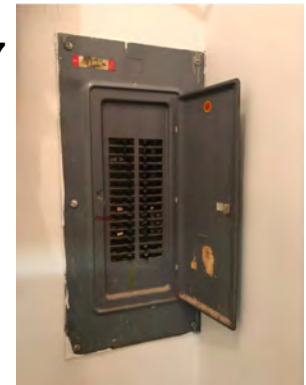
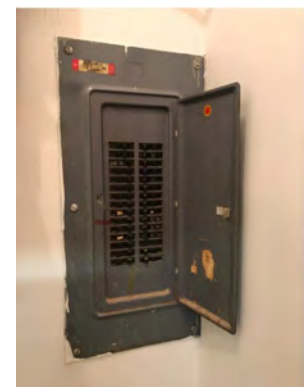
The electrical distribution system for this building includes panelboards, feeders, and associated equipment. Years remaining have been increased because the system is currently functioning, however the system is beyond its useful life and should be budgeted for repair/replacement.

Auto generated renewal for Distribution Equipment, Panelboards, and Feeders - 1952. System Description: The electrical distribution system for this building includes panelboards, feeders, and associated equipment. Years remaining have been increased because the system is currently functioning, however the system is beyond its useful life and should be budgeted for repair/replacement.

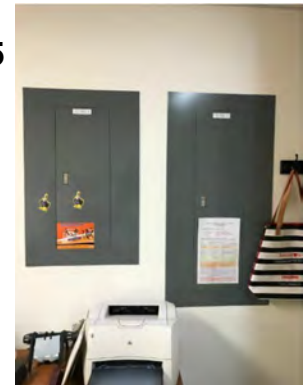
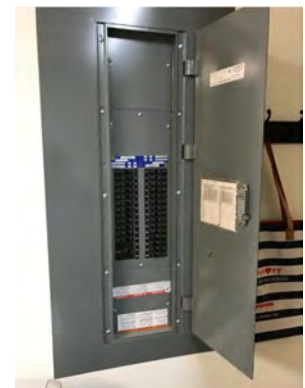
The electrical distribution system for this building includes panelboards, feeders, and associated equipment.

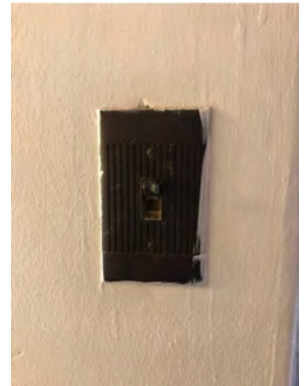
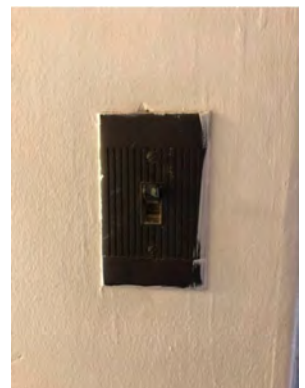
Branch wiring for this building includes interior and exterior branch wiring, devices, and utilization equipment. Years remaining have been increased because the system is currently functioning, however the system is beyond its useful life and should be budgeted for repair/replacement.

Auto generated renewal for Branch Wiring - Equipment & Devices - 1952. System Description: Branch wiring for this building includes interior and exterior branch wiring, devices, and utilization equipment. Years remaining have been increased because the system is currently functioning, however the system is beyond its useful life and should be budgeted for repair/replacement.

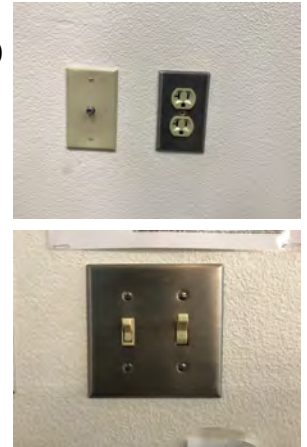
Branch wiring for this building includes interior and exterior branch wiring, devices, and utilization equipment.

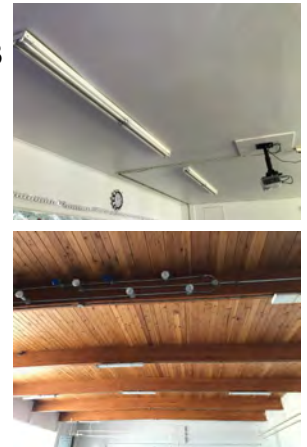
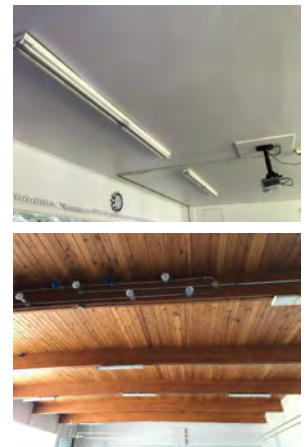
The lighting system includes lighting fixtures, lamps, conduit and wire. Years remaining have been increased because the system is currently functioning, however the system is approaching the end of its useful life and should be budgeted for repair/replacement.

Auto generated renewal for Lighting Fixtures. System Description: The lighting system includes lighting fixtures, lamps, conduit and wire. Years remaining have been increased because the system is currently functioning, however the system is approaching the end of its useful life and should be budgeted for repair/replacement.

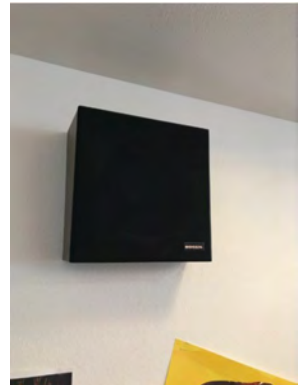
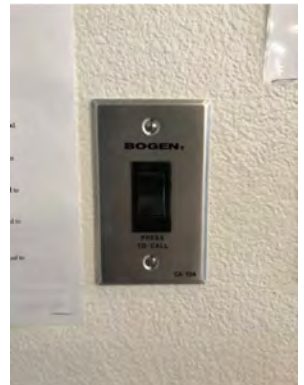
Intercom System

The building includes an intercom system.

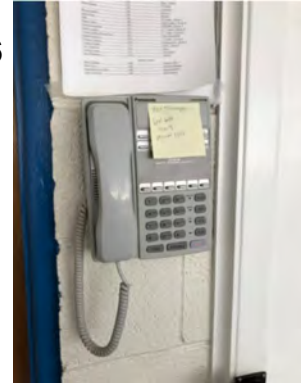
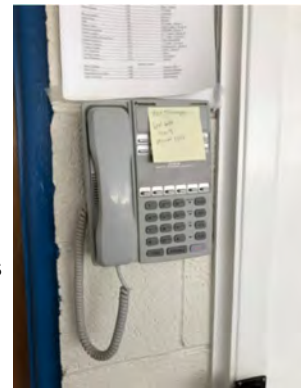
The building includes a telephone system. Years remaining have been increased because the system is currently functioning, however the system is beyond its useful life and should be budgeted for repair/replacement.

Auto generated renewal for Telephone System. System Description: The building includes a telephone system. Years remaining have been increased because the system is currently functioning, however the system is beyond its useful life and should be budgeted for repair/replacement.

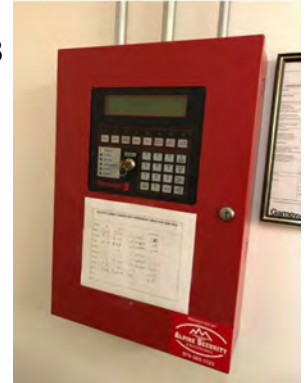
The fire alarm system includes head end equipment, pull stations, audio/visual strobes, visual strobes, smokes, conduit, wire and connections. Years remaining have been increased because the system is currently functioning, however the system is beyond its useful life and should be budgeted for repair/replacement.

Auto generated renewal for Fire Alarm System. System Description: The fire alarm system includes head end equipment, pull stations, audio/visual strobes, visual strobes, smokes, conduit, wire and connections. Years remaining have been increased because the system is currently functioning, however the system is beyond its useful life and should be budgeted for repair/replacement.

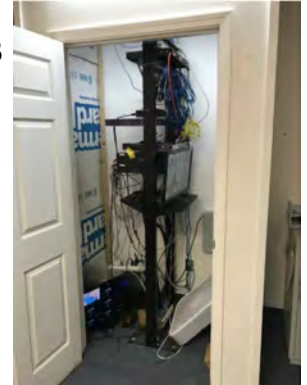
Building includes a local area network system. Years remaining have been increased because the system is currently functioning, however the system is beyond its useful life and should be budgeted for repair/replacement.

Auto generated renewal for LAN System. System Description: Building includes a local area network system. Years remaining have been increased because the system is currently functioning, however the system is beyond its useful life and should be budgeted for repair/replacement.

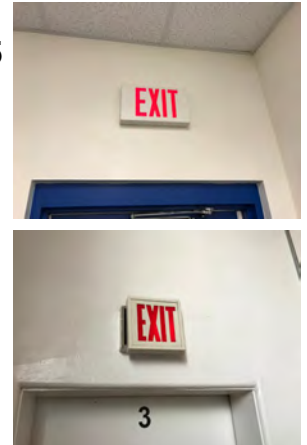
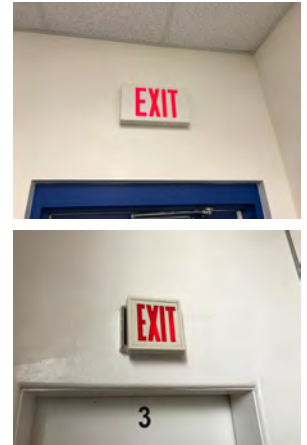
The emergency lighting system includes the installation of Exit signs. Installation includes single and double sided Exit signs, conduit, wire, boxes, conduit bends, connections and circuit breakers. Years remaining have been increased because the system is currently functioning, however the system is beyond its useful life and should be budgeted for repair/replacement.

Auto generated renewal for Exit Signs. System Description: The emergency lighting system includes the installation of Exit signs. Installation includes single and double sided Exit signs, conduit, wire, boxes, conduit bends, connections and circuit breakers. Years remaining have been increased because the system is currently functioning, however the system is beyond its useful life and should be budgeted for repair/replacement.

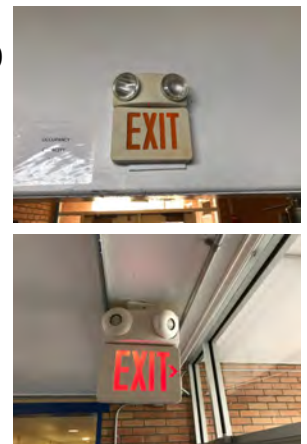
The emergency lighting system includes the installation of combination exit signs/emergency lighting. Installation includes: single and double sided Exit signs with emergency lighting, conduit, wire, boxes, conduit bends, connections and circuit breakers. Years remaining have been increased because the system is currently functioning, however the system is beyond its useful life and should be budgeted for repair/replacement.

Auto generated renewal for Combination Exit Signs/Emergency Lighting. System Description: The emergency lighting system includes the installation of combination exit signs/emergency lighting. Installation includes: single and double sided Exit signs with emergency lighting, conduit, wire, boxes, conduit bends, connections and circuit breakers. Years remaining have been increased because the system is currently functioning, however the system is beyond its useful life and should be budgeted for repair/replacement.

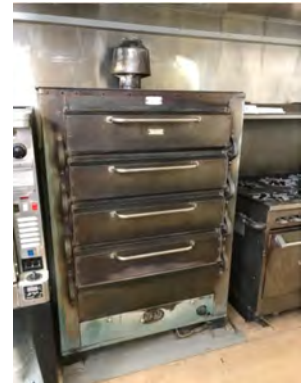
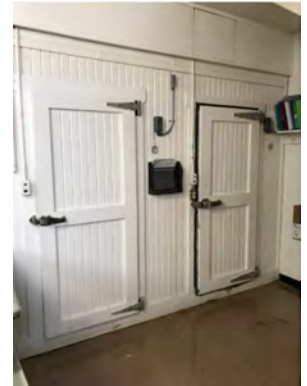
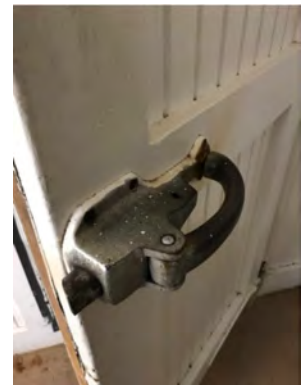
Equipment and furnishings includes kitchen equipment. Years remaining have been increased because the system is currently functioning, however the system is beyond its useful life and should be budgeted for repair/replacement.

Auto generated renewal for Kitchen Equipment. System Description: Equipment and furnishings includes kitchen equipment. Years remaining have been increased because the system is currently functioning, however the system is beyond its useful life and should be budgeted for repair/replacement.

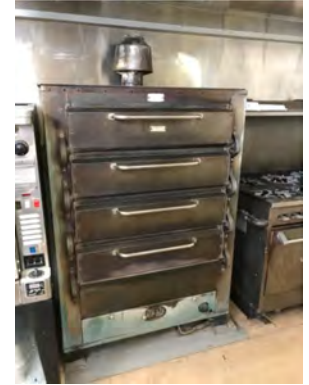
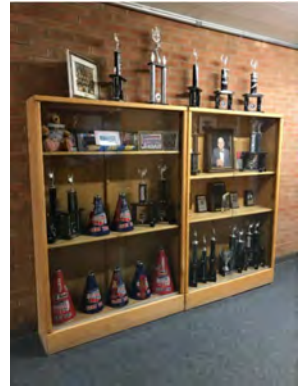
Fixed Casework - 1952

The building includes laminate casework, including wall and under-counter cabinets and counter-tops. Years remaining have been increased because the system is currently functioning, however the system is beyond its useful life and should be budgeted for repair/replacement.

Auto generated renewal for Fixed Casework - 1952. System Description: The building includes laminate casework, including wall and under-counter cabinets and counter-tops. Years remaining have been increased because the system is currently functioning, however the system is beyond its useful life and should be budgeted for repair/replacement.
